OPEN FILE REPORT – NH-03

**The rockslide of Arvel
caused by human
activity (Villeneuve,
Switzerland):
Summary, partial
reinterpretation and
comments of the work
of Choffat, Ph. (1929):
L'écroulement d'Arvel
(Villeneuve) de 1922.
Bull. SVSN 57, 5-28.**

By M. Jaboyedoff

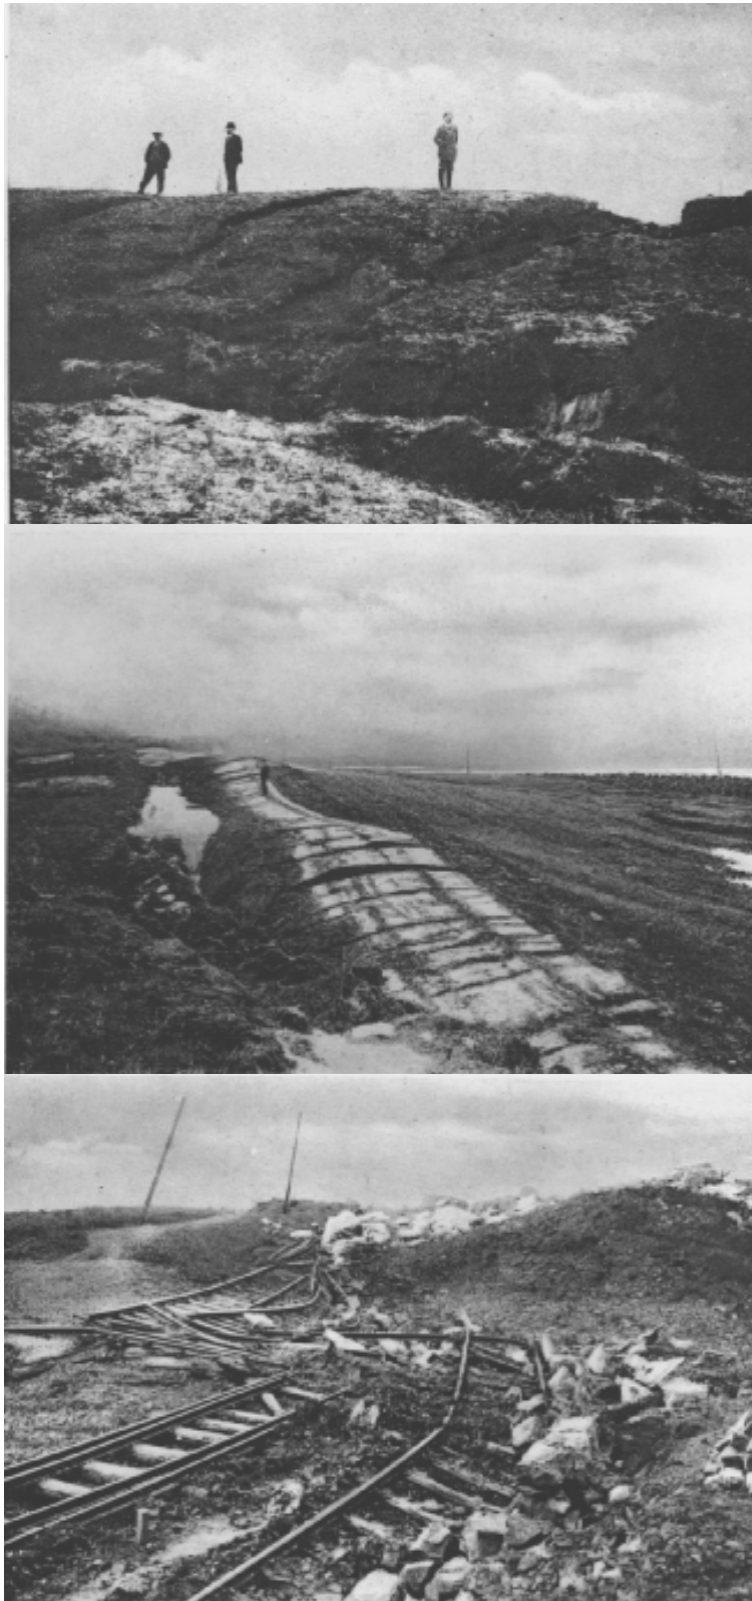
Fig. 8: Picture of the effect of the rock-fall on the alluvial, which created hills and large horizontal displacements.

The alluvial sediments were strongly disturbed by the fall down of the rock mass (Figs 8 and 9). They have a thin-skinned tectonic like style (Fig. 3). They were expelled above detachment surface away in the valley. The result was arched hills around the rock fall deposit. Their height can reach 7 m above the previous topography. Transversal fissures that indicate longitudinal extension affect those hills.
